# Value-Lift Maintenance Sheet

## TOP RAIL PIVOT NOISE DURING TABLE HEIGHT ADJUSTMENTS

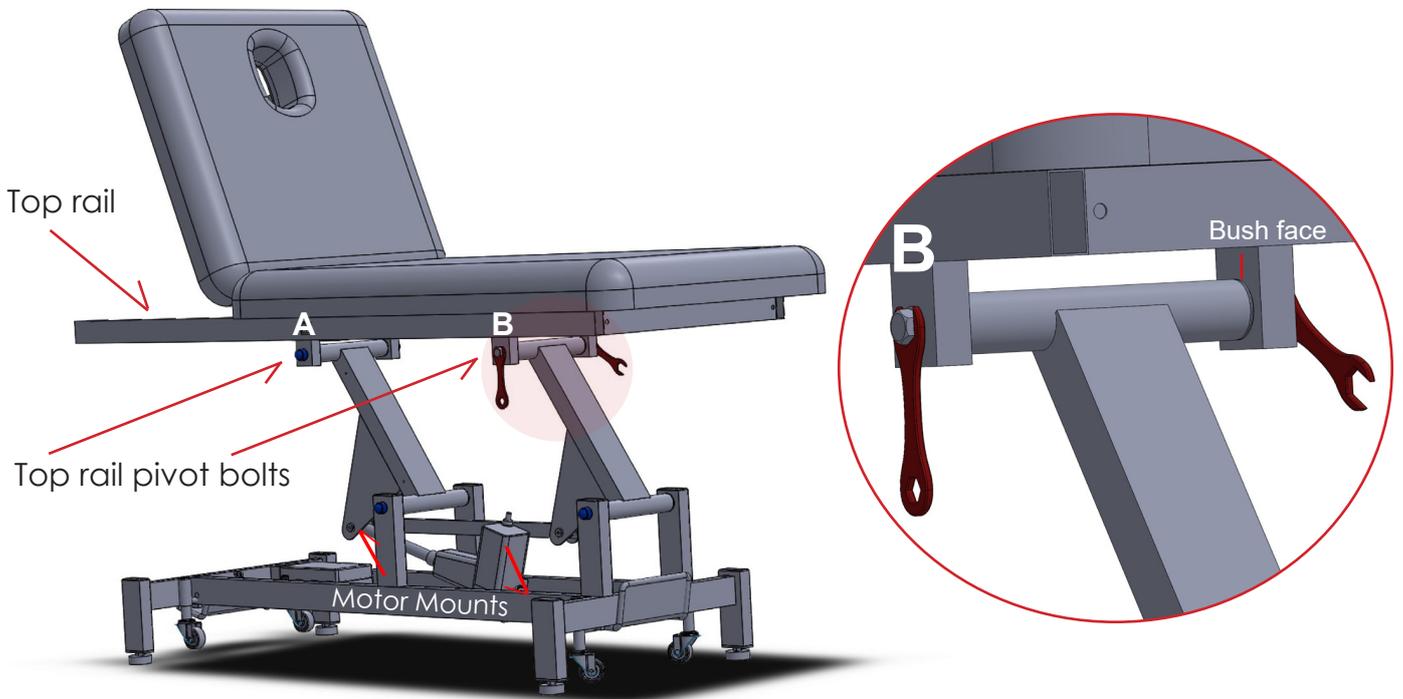
### Noise during height adjustments due to pivot point being overly tightened in assembly.

### If the table is still noisy during height adjustments, the noise is due to an overly tight manufacturing tolerance.

1. Locate pivot bolts on the top rail (marked A & B above). Note both bolts go right through to the other side of the top rail.
2. Remove plastic black dome caps on either side of the pivot bolt. Use large pliers to do this.
3. Hold the bolt nut on one side of the top rail with a spanner while you turn the other side by an eighth to a quarter turn. Lubricate with a heavy-bodied grease where the bush makes contact with the inside of the top rail.
4. Remember to do both A and B bolts. This should loosen the top rail sufficiently so that it no longer makes any noise during table height adjustments. Lubricate both motor mounts (top and bottom).

5. Remove a bolt nut from one side of the bolt.
6. Using a long pin, hammer the bolt right through (do both A and B bolts).
7. Lift off the tabletop.
8. Replace bushes with new thinner bushes (contact Athlegen for supply) OR sand the plastic white bushes that the bolts go through by 0.5mm. Use an electric sander or a fine steel file. To do this evenly, you can block out the bush surface with a permanent marker. This will give you a visual guide while sanding.
9. Lubricate bush surface with a heavy-bodied grease.
10. Assemble top.
