# Centurion Value-Lift Massage

## HEAD CRADLE ADJUSTMENT

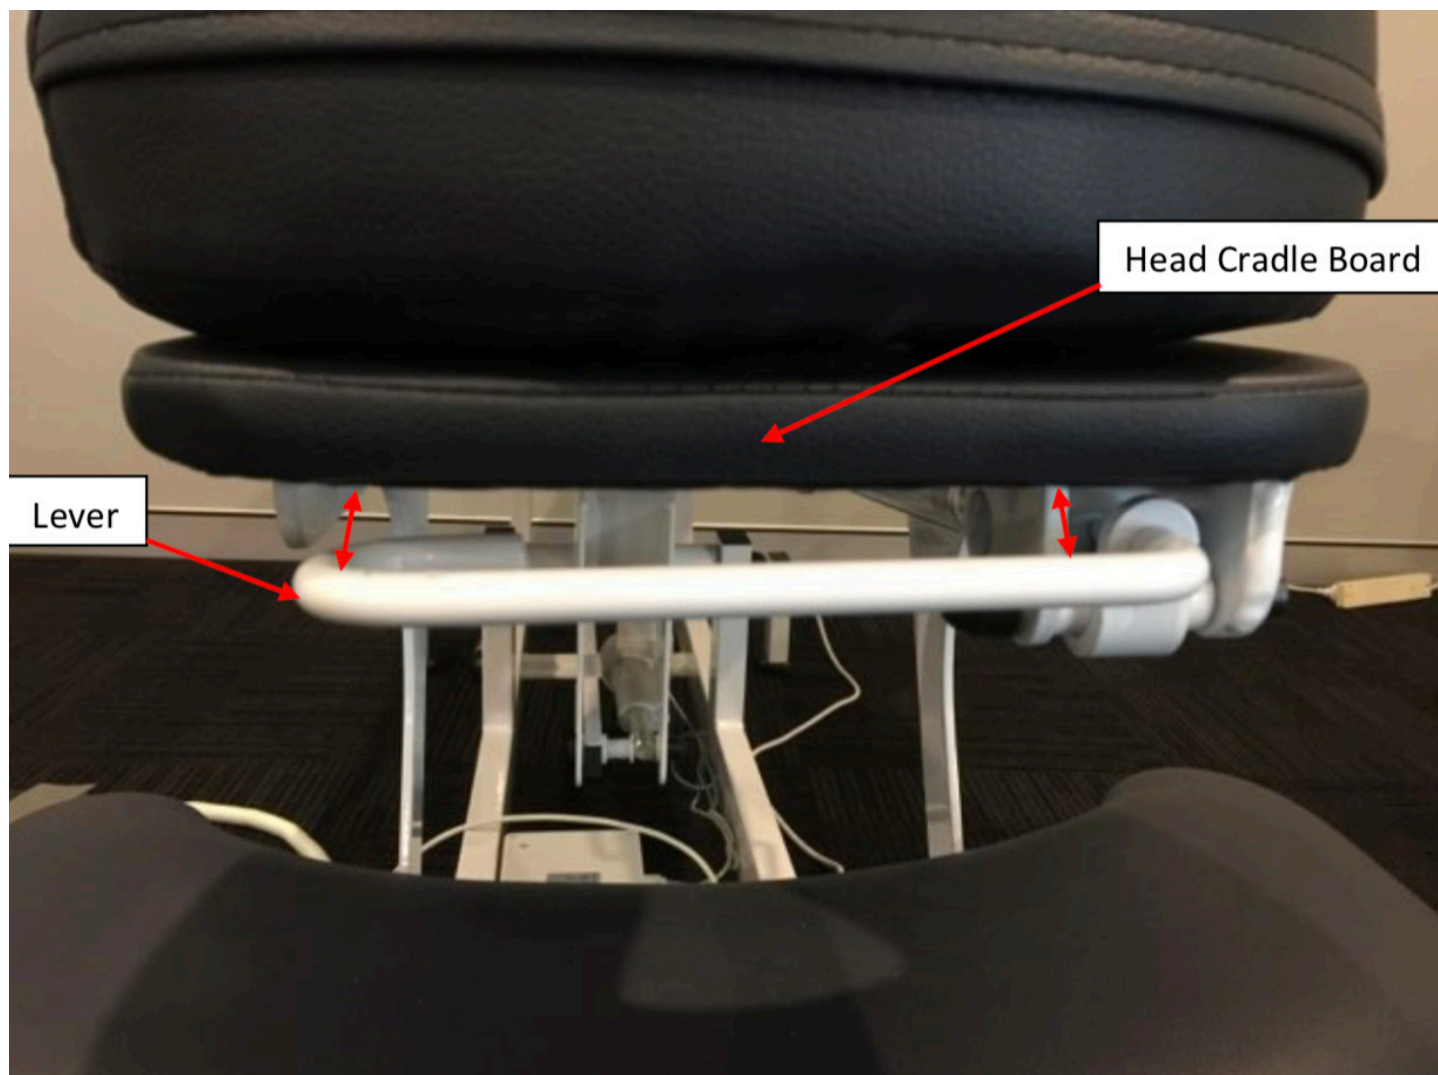
If head cradle is stiff during adjustment, lever should have slightly more clearance on the left-hand side than the right-hand side of the head cradle board. If this is not the case, hold the lever on the left-hand side and pull (bend) down.

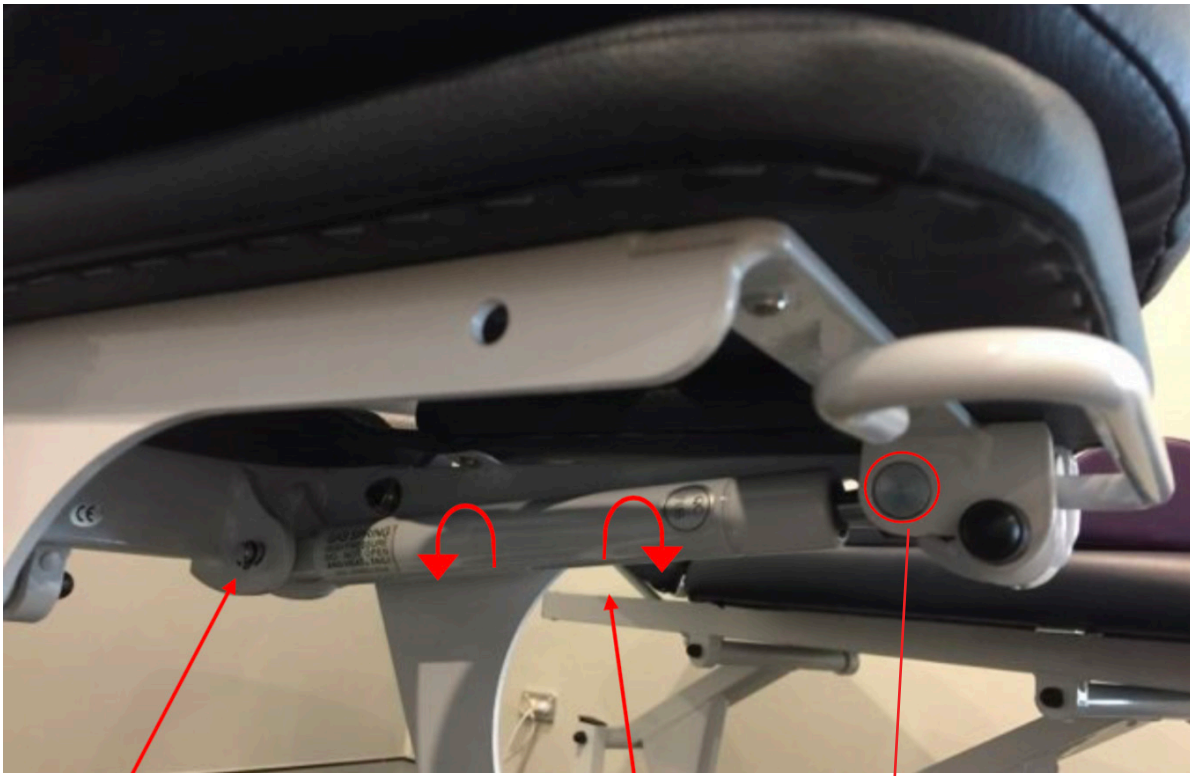
If the head cradle does not hold, remove this bolt and adjust the gas strut two turns anti-clockwise.

If the head cradle does not adjust at all, adjust the gas strut two turns clockwise. Put bolt back in place.

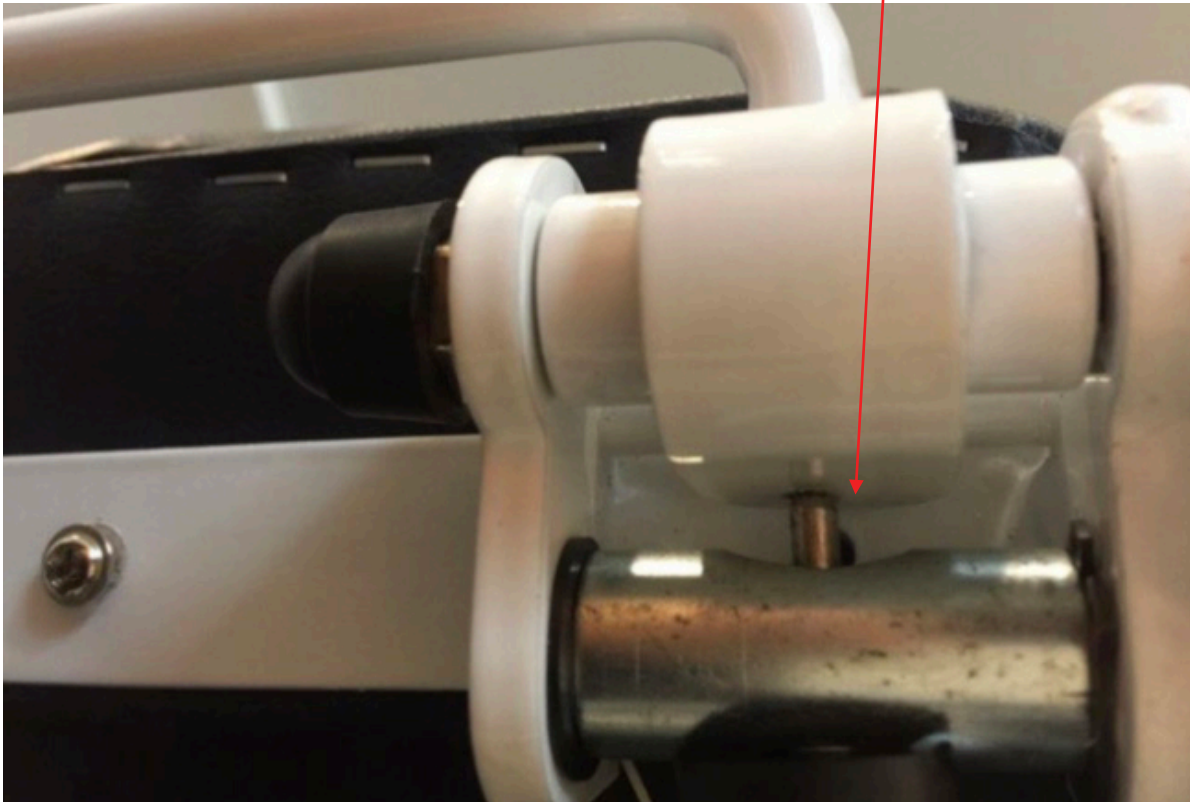
Image shows the front view of the gas strut pin. Pin should be fully extended when not activated. If it is not, head cradle will not hold.
